**QUIET CLEAN SHORT-HAUL EXPERIMENTAL ENGINE
(QCSEE)**

**Under-the-Wing (UTW) Engine Boilerplate Nacelle Test Report
VOLUME III**

Mechanical Performance

**Advanced Engineering and Technology Programs Department
GENERAL ELECTRIC COMPANY**

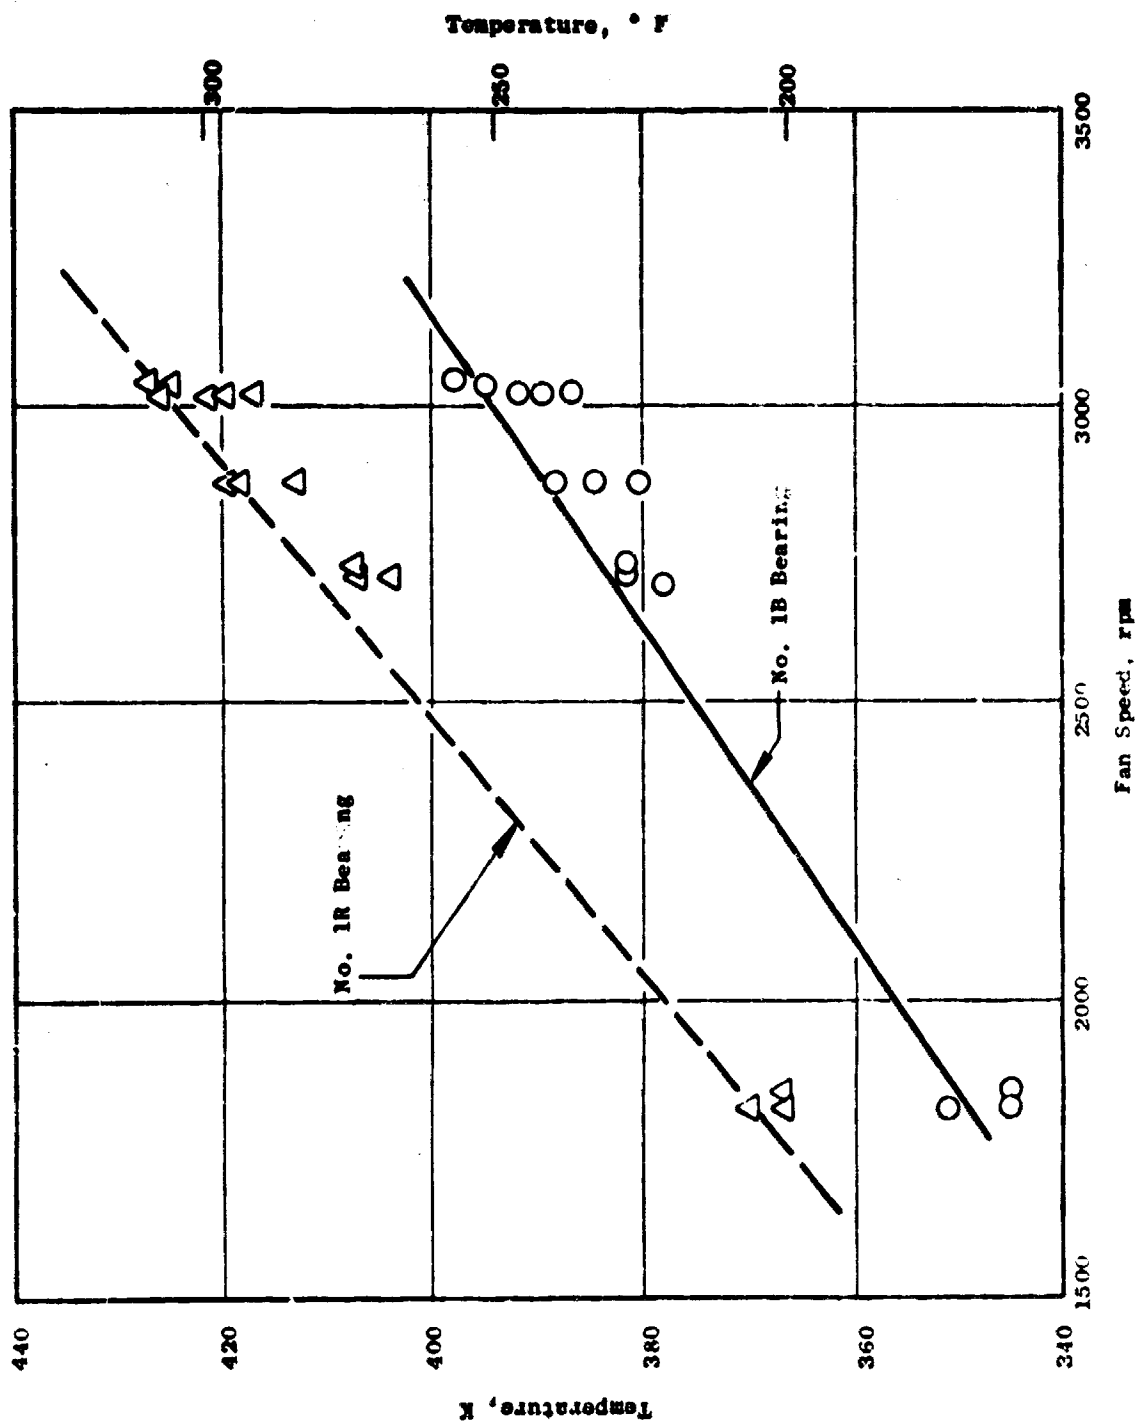
Test limits of 450 K (350° F) were not exceeded by any of the main shaft bearings during the majority of the testing. Figures 22 through 24 show representative temperature data for these bearings as a function of engine speed. The No. 2 ball thrust bearing experienced temperatures of 588 K (600° F) on three occasions for very short periods of time before the oil flooding problem was identified in the accessory gearbox. This high temperature was a result of overheated oil discharged from the accessory gear-

Figure 22. Outer Race Temperature Versus Fan Speed.

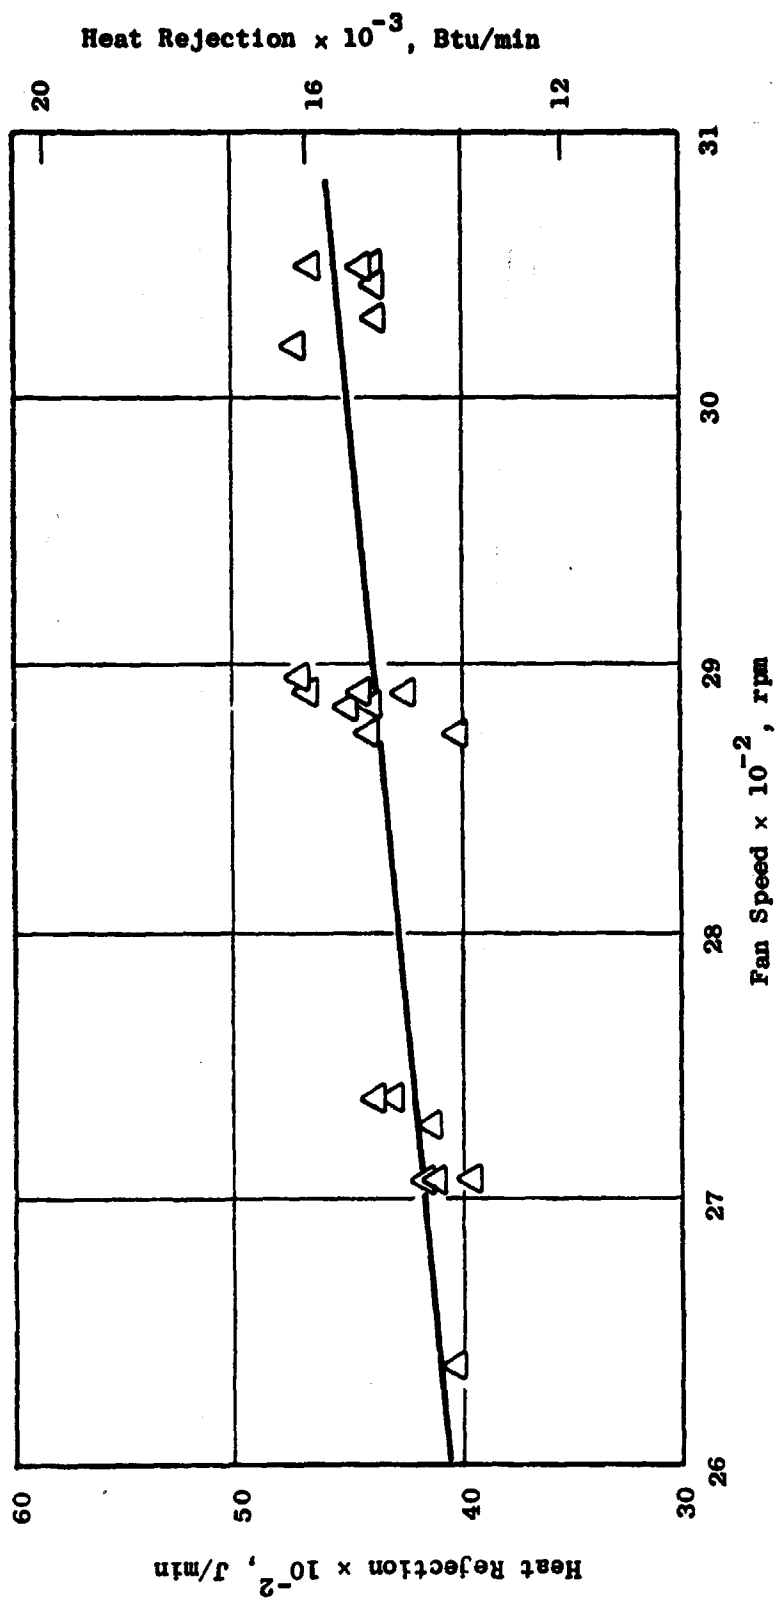
Figure 27. Engine Heat Rejection Versus Fan Speed.

The increased engine heat rejection was caused by lower-than-expected efficiency in the main reduction gears and the added heat load of approximately 587 J/min (2000 Btu/min) for the partially oil-flooded accessory gearbox.

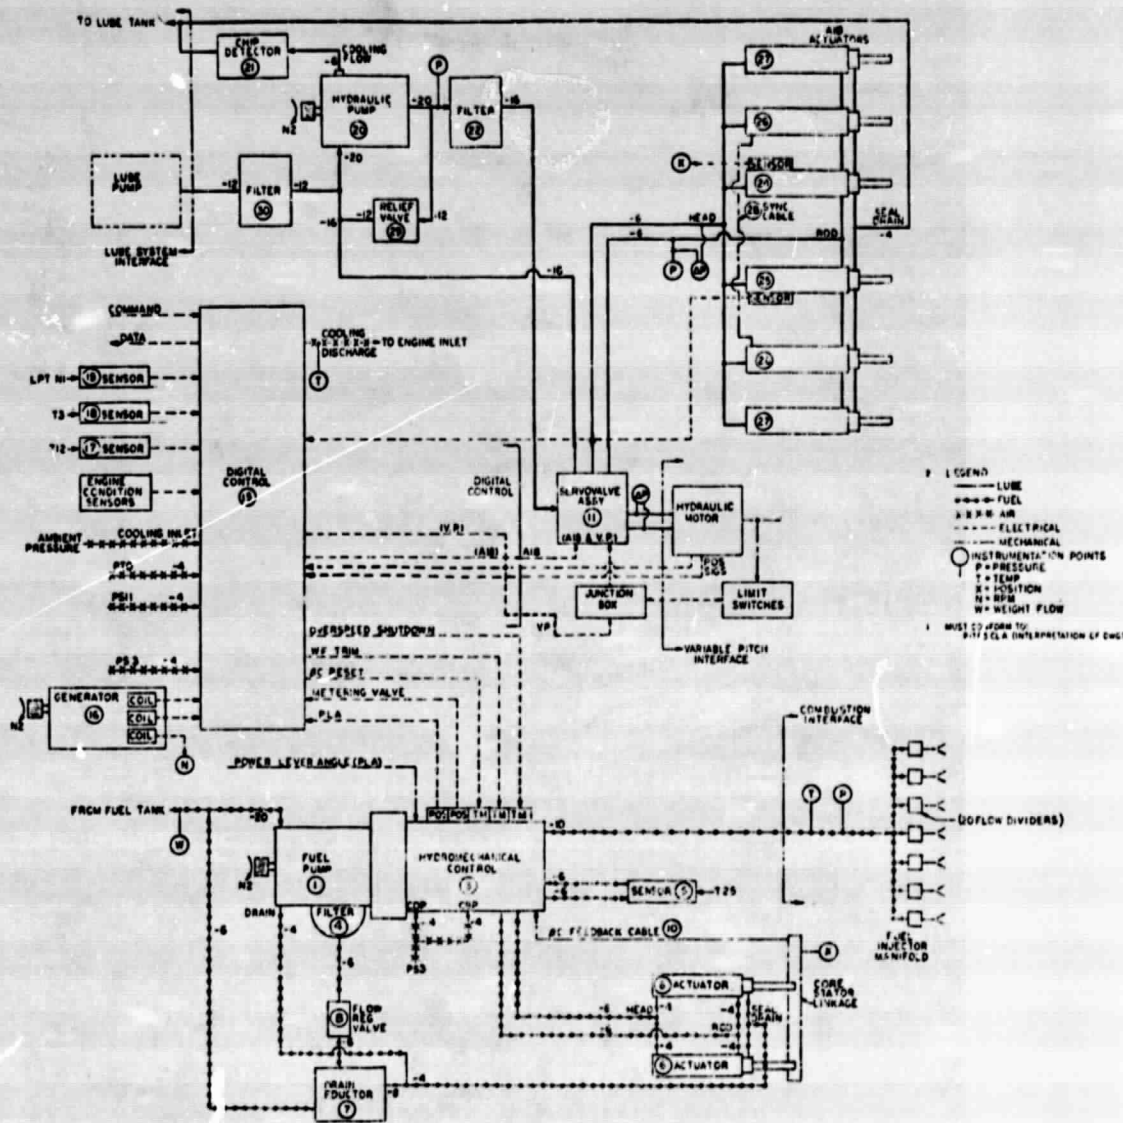
A schematic diagram of the QCSEE UTW Control System is shown in Figure 36. The digital electronic control was the heart of the system and controlled the manipulated variables in response to commands representing those which would be received from an aircraft propulsion system computer. A photograph of the engine-mounted digital control is shown in Figure 37. The system included a modified F101 hydromechanical control. This control included an electrohydraulic torque motor servovalve through which the digital control maintained primary control of fuel flow. The fuel-operated servomechanisms in the hydromechanical control served primarily as backup fuel controlling elements and limits although they were the primary controlling elements for the core compressor stator actuators.

Figure 36. System Interconnection Schematic.

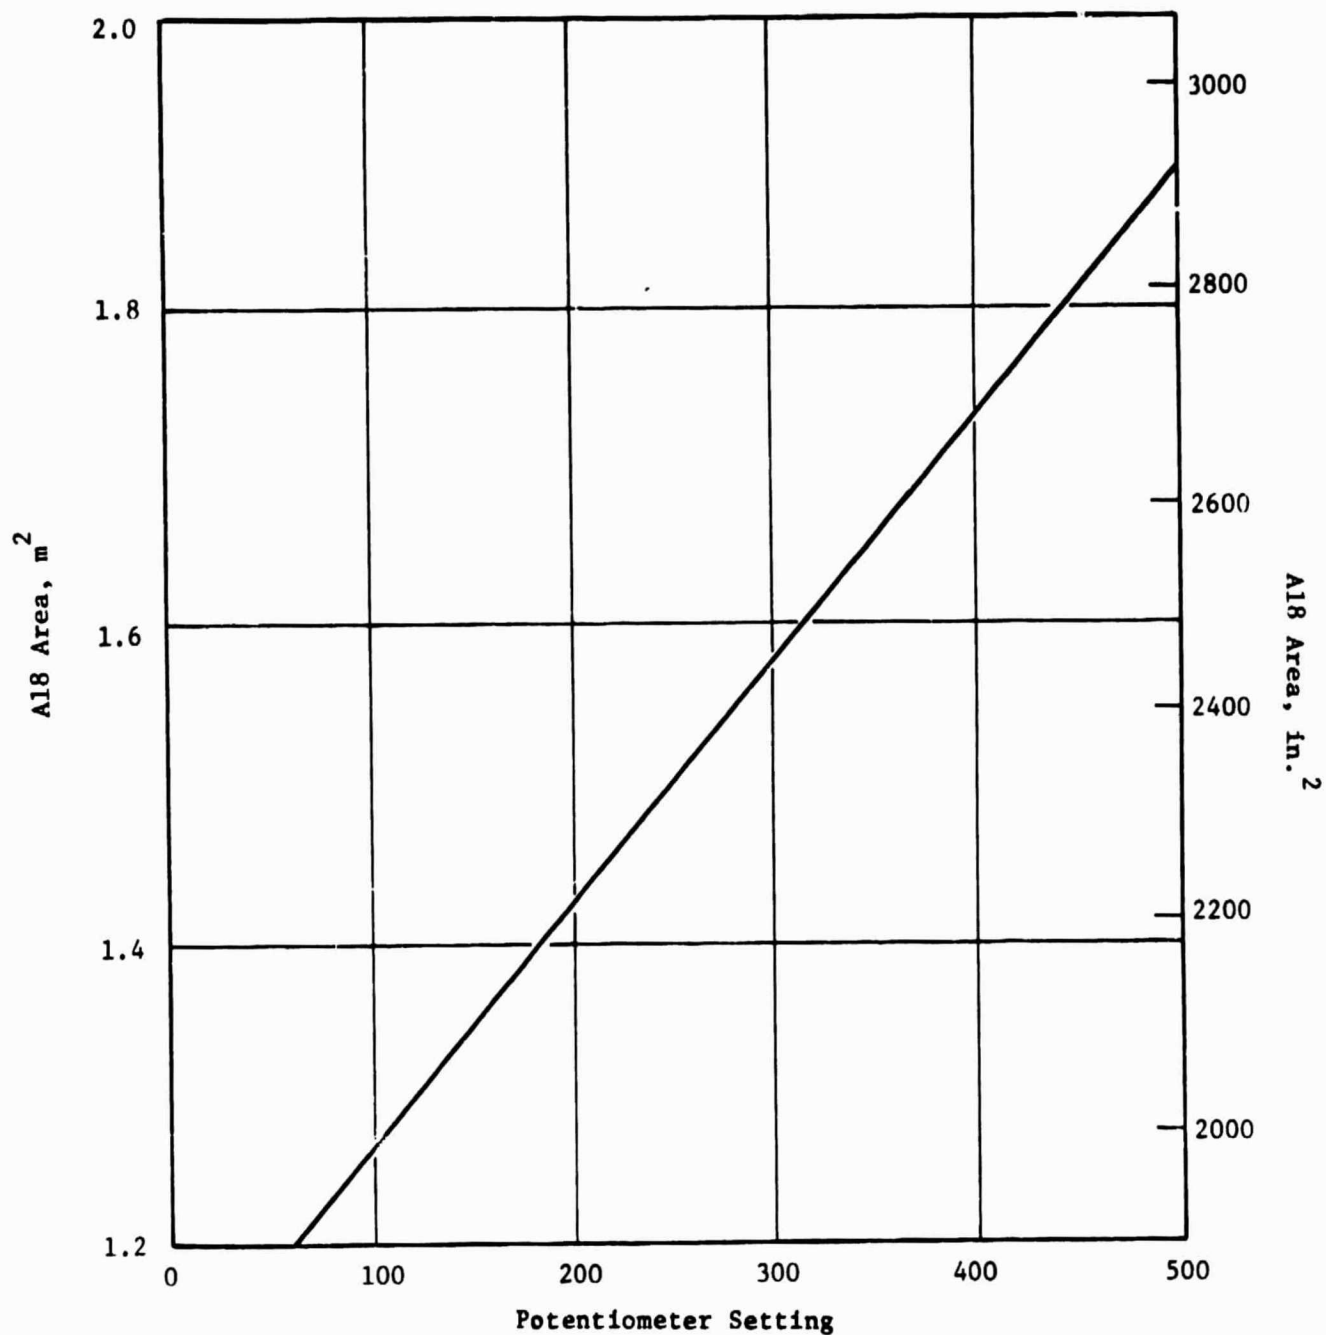
The plot of demand position versus calculated A18 area is shown in Figure 45. A plot of calculated A18 area versus engineering panel readout EPMI/04 is shown in Figure 46. From these data the following equation was

Figure 45. Fan Nozzle Area Versus Demand Potentiometer Setting.

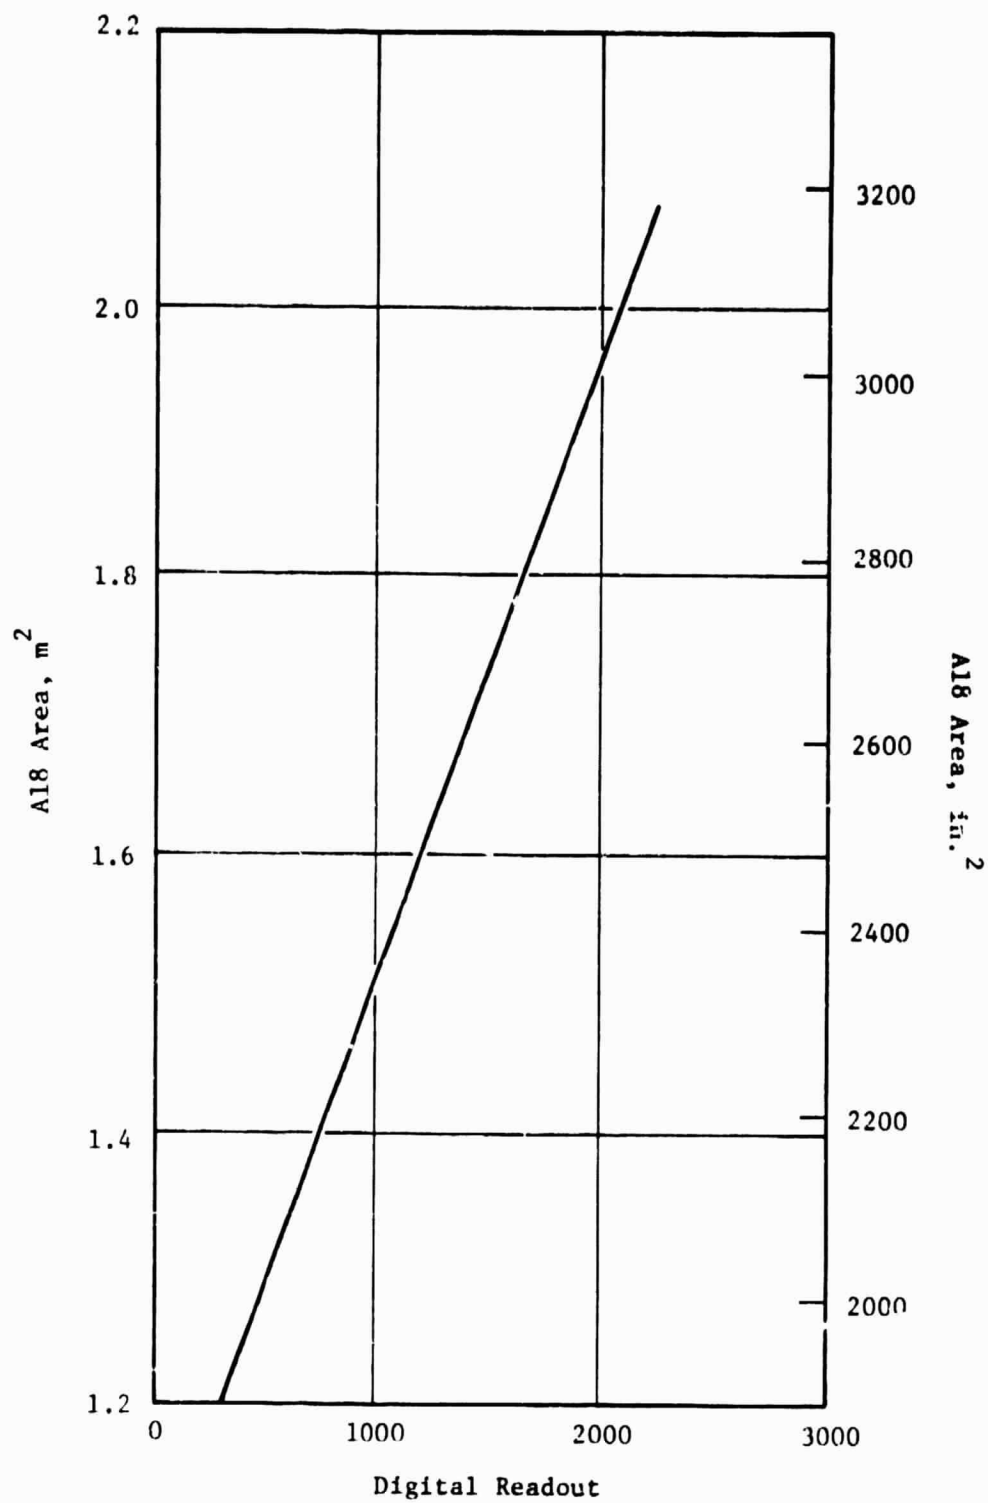
Figure 46. Fan Nozzle Area Versus Digital Readout.

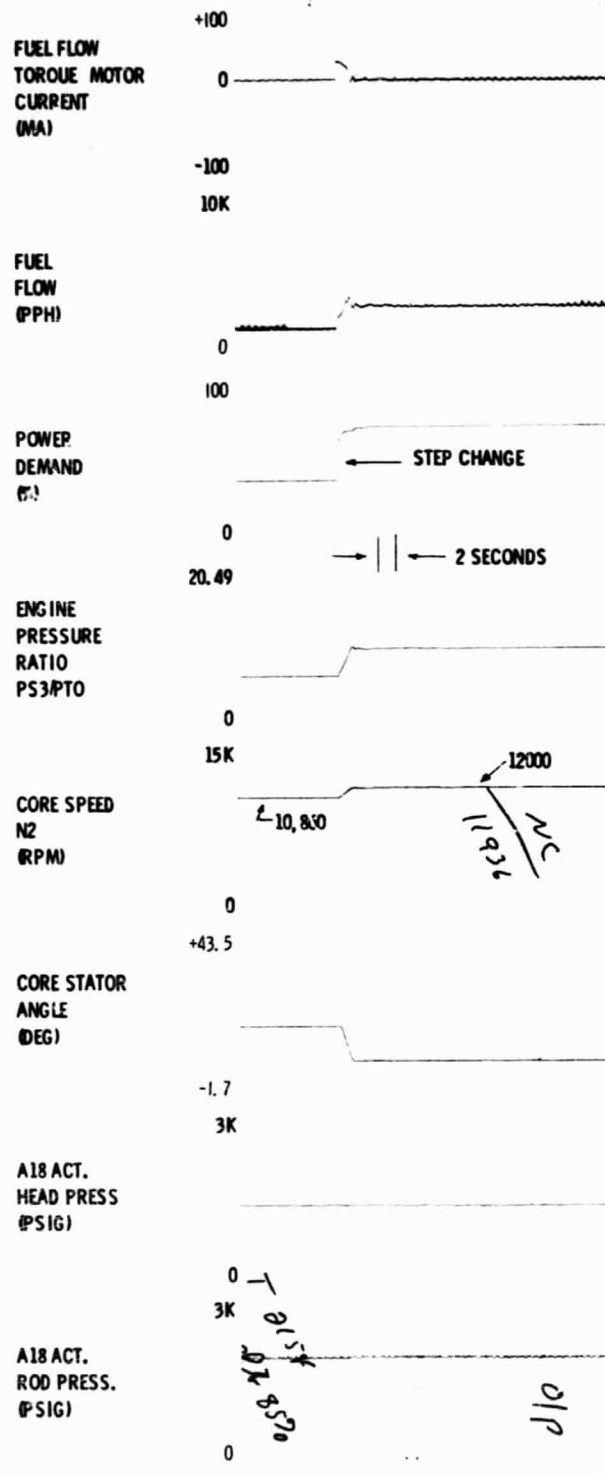
Figure 50. QCSEE UTW Power Change, Idle to 12,000 rpm.

Operation in the fan speed control mode was accomplished by movement of the power demand potentiometer on the operator panel. The transfer from core-speed control to fan-speed control and vice versa on deceleration was smooth and without any observable discontinuities. Recorded data showing physical fan speed as a function of power demand is shown in Figure 49. In this control mode, fan speed was stable and held the desired operating point within 2 rpm. To avoid certain fan critical speeds, rapid accelerations and decelerations were made between 2100 and 2500 fan rpm. This transient operation accounts for the break in data points on Figure 49. The control system successfully accelerated and decelerated the engine through this critical region. A typical transient is shown in Figure 50.

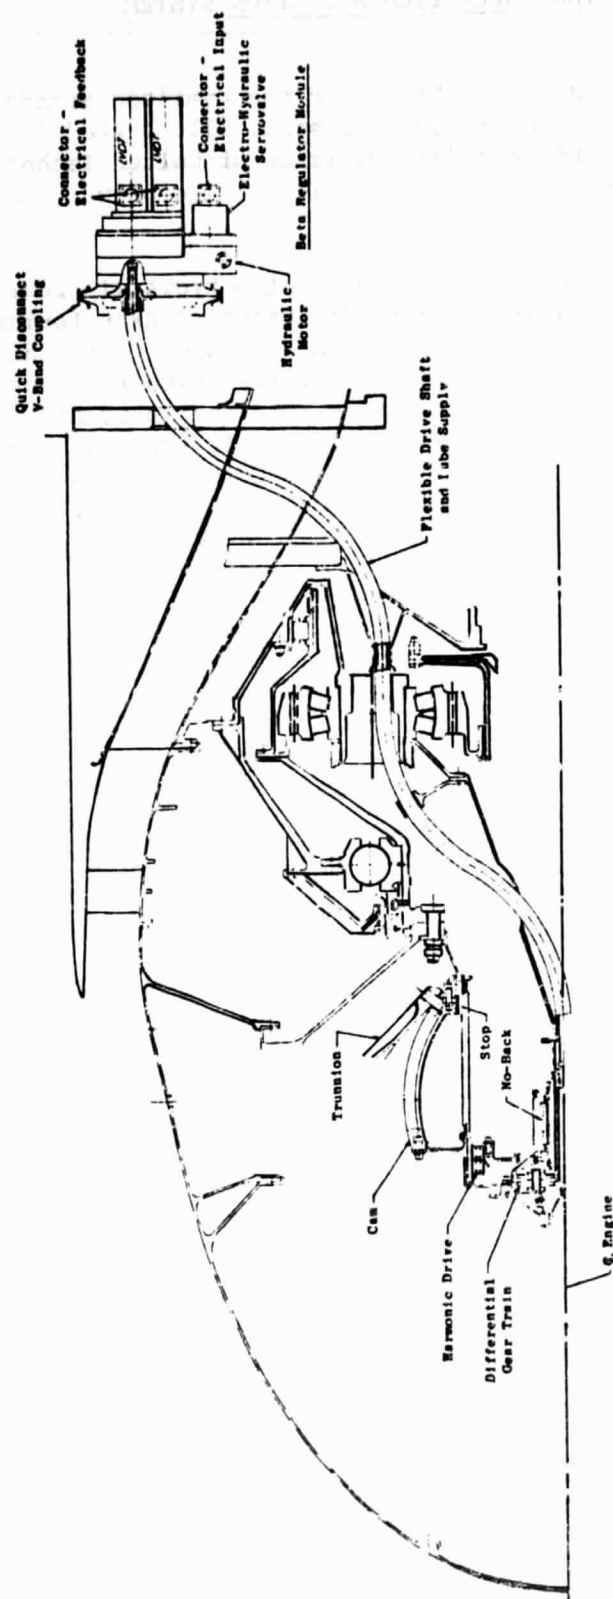
Figure 63. QCSEE UTW Build 1 Variable-Pitch Actuation System.

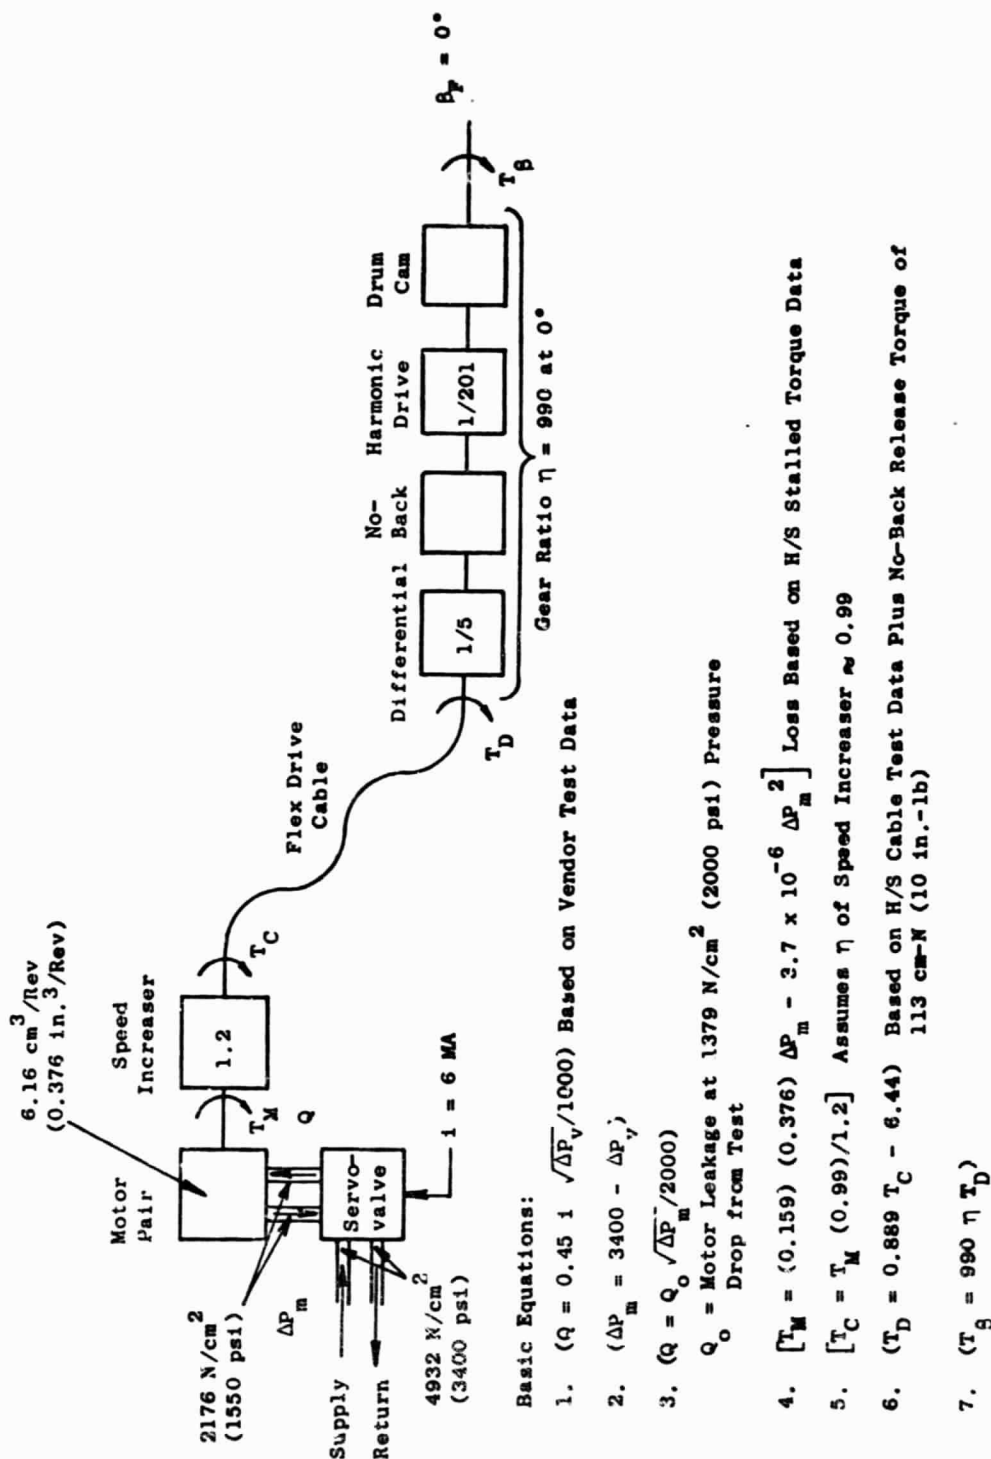
Figure 67. Description of V-P Mechanism Used in Analysis.
